**Flood Control Project Maintenance  
Levee Inspections**  
**LMA District Cover Sheet**  
**Spring 2017 Levee Inspection Results**

**Reclamation District No. 2092 Dos Rios**

**Spring 2017 Levee Inspection Results**

Waterway			Bank	Unit Miles
Unit No. 01 San Joaquin River			Right	3.71
	Spring (March - May)	Summer (June - August)	(September - November) Fall	Winter (December - February)
Unit Maintenance Rating (Fall Only)				
Date of Inspection	4/7/2017 - 4/7/2017			
DWR Inspector	Pavel Kazi			
Accompanied By	Hayo Tjarks River Partner

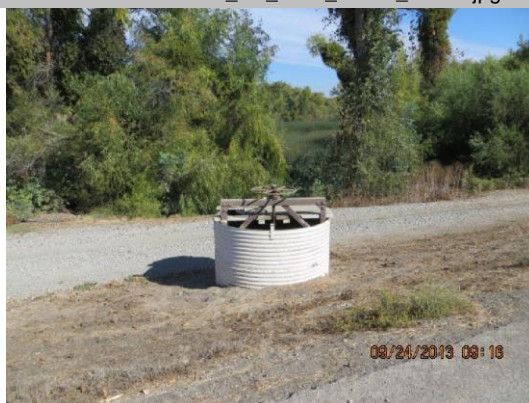
Photo 1 of 3 : UCIP\_SP\_2017\_27123\_50242.jpg

LM Start	0.18	Rating **	M	Issue No.	973
LM End	0.18	Issue Type +	Ma	Location *	N/A
Category	Supplemental			GPS Latitude/Longitude	
				Start	End
Item	DWR UCIP LMA Responsibility			37.602031 °	37.602031 °
				-121.161249 °	-121.161249 °
DWR ID					
Comment Code					
Inspector Comment					
FS_ID:27123 DS_ID:20561 EP_NO: N/A Repair Type: Non-Urgent Crossing Status: Found UCIP Comments: Pipe rusted through at headwall on LS toe. Good candidate for video inspection. FIELD_STRUCT_DESC: 60-inch corrugated metal drainpipe through levee 19.0 feet below crown. Flap gate on the waterward end. Slide gate in 80-inch corrugated metal pipe riser on the waterward slope. Concrete "U" headwalls on both ends. Originally included in the 1961 O&M manual. FS Date: 1/16/2014 12:03:14 PM

Slide gate in 80-inch CMP riser on WS slope.

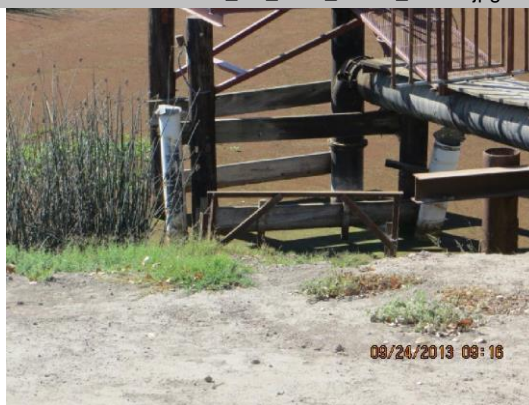
Photo 2 of 3 : UCIP\_SP\_2017\_27123\_50241.jpg

Concrete headwall on LS toe in front of pump on pier.

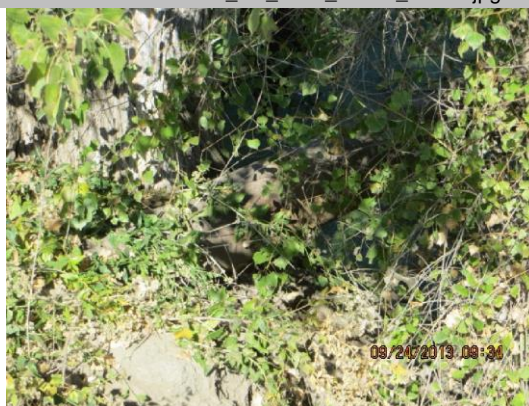
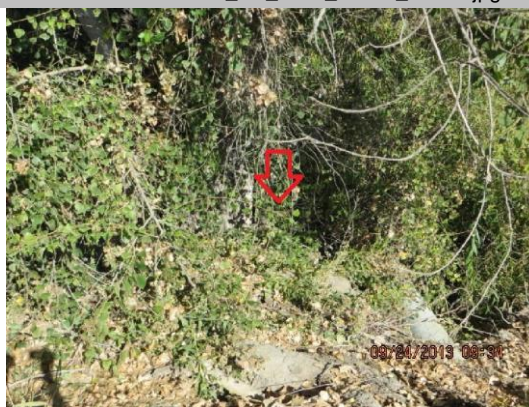
LM Start	0.19	Rating **	M	Issue No.	975
LM End	0.19	Issue Type +	En	Location *	N/A
Category	Supplemental			GPS Latitude/Longitude	
				Start	End
Item	DWR UCIP Field Study			37.601976 °	37.601976 °
				-121.161395 °	-121.161395 °
DWR ID					
Comment Code					
Inspector Comment					
FS_ID:20885 DS_ID:20579 EP_NO: 6254 Repair Type: Non-Urgent Crossing Status: Found UCIP Comments: Verify pipe has bee removed from levee. Pipe visible on WS at riverbank. FIELD_STRUCT_DESC: *ABANDONED* 16-inch steel pipe over the levee with 3.5 feet of fill on top. Siphon breakers on waterward shoulder. Pad constructed over pipes. This pumping plant was constructed in 1969 during emergency conditions without a permit (Permit No. 6254, 1968). FS Date: 9/24/2013

Pipe visible at rivers edge on WS toe.

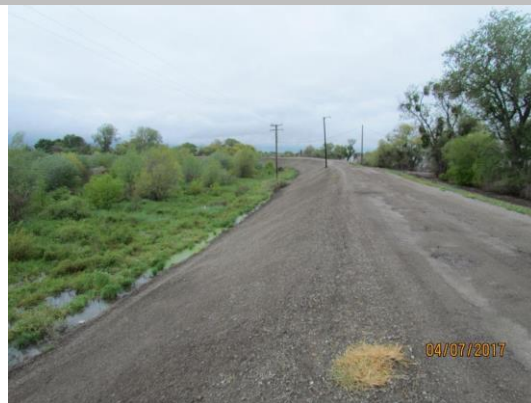
Photo 1 of 1 : SP\_2017\_RD2092\_116\_17\_20170417\_00036.jpg

View of the landside of the levee. Spring 2017

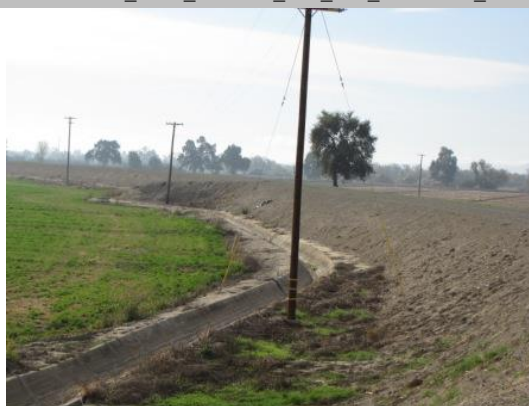
Photo 1 of 1 : SP\_2017\_RD2092\_116\_968\_20170327\_00006.jpg

View of agricultural ditch at the landward toe looking upstream.

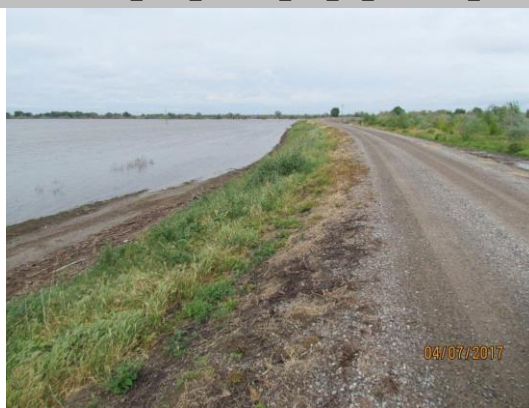
Photo 1 of 1 : SP\_2017\_RD2092\_116\_19\_20170417\_00044.jpg

LM Start	0.87	Rating **	M	Issue No.	19
LM End	1.31	Issue Type +	Ma	Location *	WS
Category	Earthen Levee			GPS Latitude/Longitude	
				Start	End
Item	Vegetation			37.595725 °	37.590537 °
				-121.168175 °	-121.163975 °
DWR ID	DWR_RD2092_01_s_2017_19				
Comment Code					
V1 : Control annual grass and weeds on the levee slopes and easements.					
Inspector Comment

View of vegetation on the waterside of the levee.

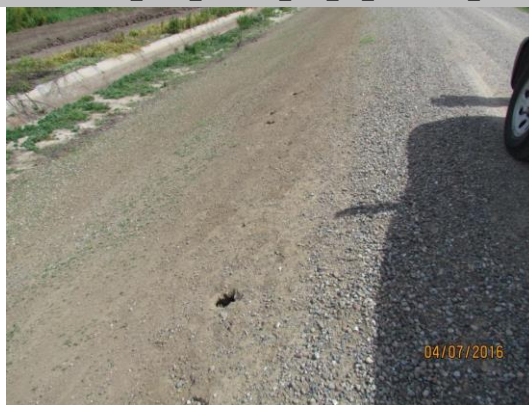
Photo 1 of 1 : SP\_2017\_RD2092\_116\_15\_20170327\_00004.jpg

LM Start	1.21	Rating **	M	Issue No.	15
LM End	1.21	Issue Type +	Ma	Location *	LS
Category	Earthen Levee			GPS Latitude/Longitude	
				Start	End
Item	Animal Control			37.591293 °	37.591293 °
				-121.165434 °	-121.165434 °
DWR ID	DWR_RD2092_01_s_2016_15				
Comment Code					
A3 : No rodents visible, but rodent burrows visible; need to backfill and compact or grout burrows.					
Inspector Comment

View of a rodent hole on the landside of the levee.

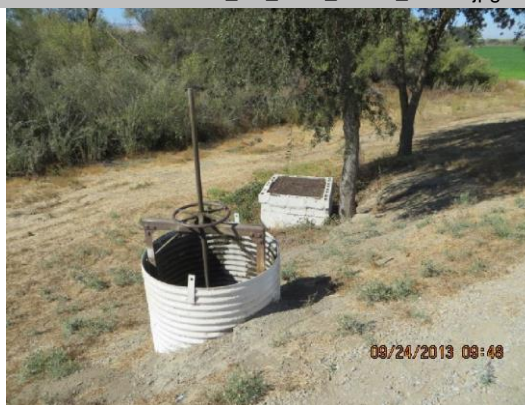
Photo 1 of 2 : UCIP\_SP\_2017\_20889\_35213.jpg

LM Start	1.30	Rating **	A/W	Issue No.	976
LM End	1.30	Issue Type +	Ma	Location *	CR
Category	Supplemental			GPS Latitude/Longitude	
				Start	End
Item	DWR UCIP LMA Responsibility			37.590603 °	37.590603 °
				-121.164111 °	-121.164111 °
DWR ID					
Comment Code					
Inspector Comment					
FS_ID:20889 DS_ID:20562 EP_NO: N/A Repair Type: No Action Needed Crossing Status: Found UCIP Comments: FIELD_STRUCT_DESC: 36-inch corrugated metal pipe through levee 15.0 feet below crown. Slide gate in 48-inch corrugated metal riser on the waterward slope. 4'X6' concrete distribution box on LS toe. 5'X5' concrete riser on WS toe. Originally included in the 1961 O&M manual. FS Date: 9/24/2013

Slide gate in 48-inch CMP riser on WS slope.

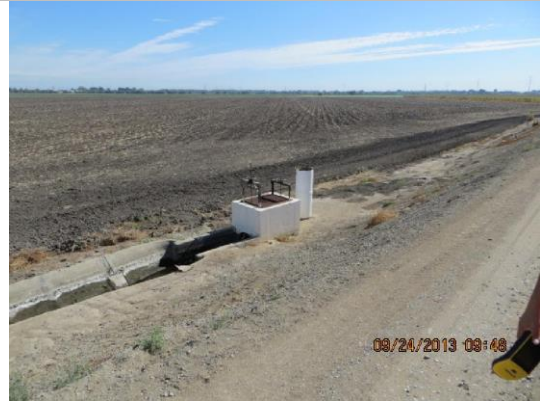
Photo 2 of 2 : UCIP\_SP\_2017\_20889\_35212.jpg

Concrete distribution box at concrete canal on LS toe.

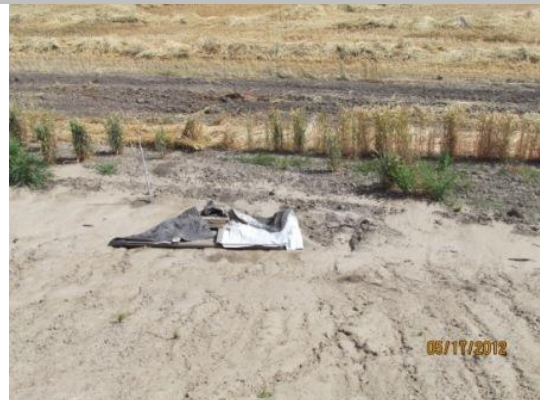
Photo 1 of 2 : SP\_2017\_RD2092\_116\_10\_20170327\_00002.jpg

LM Start	1.32	Rating **	A/W	Issue No.	10
LM End	1.32	Issue Type +	Ma	Location *	LS
Category	Earthen Levee			GPS Latitude/Longitude	
				Start	End
Item	Encroachments			37.590467 °	37.590467 °
				-121.163822 °	-121.163822 °
DWR ID	DWR_RD2092_01_s_2012_10				
Comment Code					
PI : Pipe					
Inspector Comment					
A sand boil appeared on the landside toe of the levee because of an underground pipe leakage. The pipe and boil have been repaired but should be monitored.

During spring inspection 2012, the sand boil was not active but materials were present on the landside toe of the levee. The sand boil occurred due to an underground irrigation pipe leakage. The picture was taken from the crown looking toward the toe of the levee. The area was repaired but should be monitored.

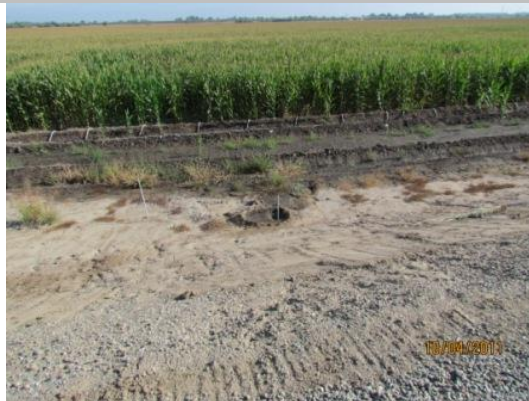
Photo 2 of 2 : SP\_2017\_RD2092\_116\_10\_20170327\_00003.jpg

A sand boil was found on the landside of the levee. It was caused by a pipe leak couple of feet below the boil location. LMA was notified to repair it as soon as possible. The picture was taken from the crown looking upstream.

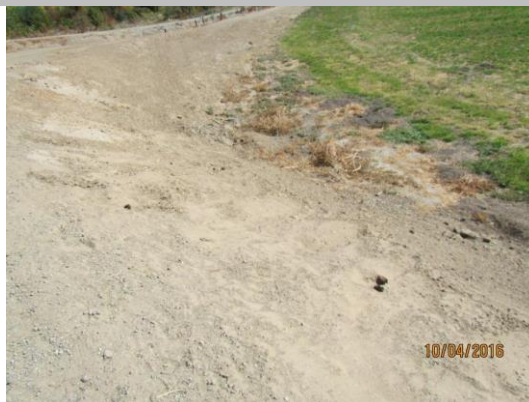
Photo 1 of 1 : SP\_2017\_RD2092\_116\_16\_20170327\_00005.jpg

LM Start	1.56	Rating **	M	Issue No.	16
LM End	1.56	Issue Type +	Ma	Location *	LS
Category	Earthen Levee			GPS Latitude/Longitude	
				Start	End
Item	Animal Control			37.587593 °	37.587593 °
				-121.162431 °	-121.162431 °
DWR ID	DWR_RD2092_01_f_2016_16				
Comment Code					
A3 : No rodents visible, but rodent burrows visible; need to backfill and compact or grout burrows.					
Inspector Comment

View of rodent holes on the landside of the levee looking downstream.

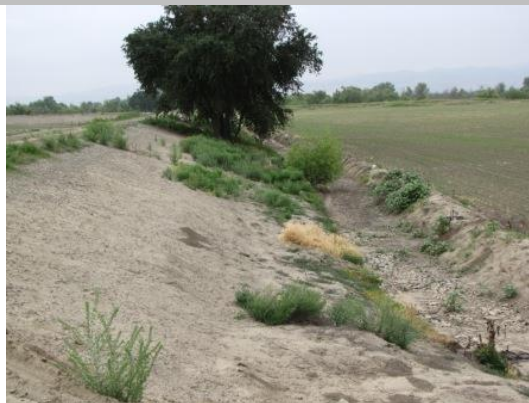
Photo 1 of 1 : SP\_2017\_RD2092\_116\_8\_20170327\_00001.jpg

View of an agricultural ditch at the waterward toe of the slope.

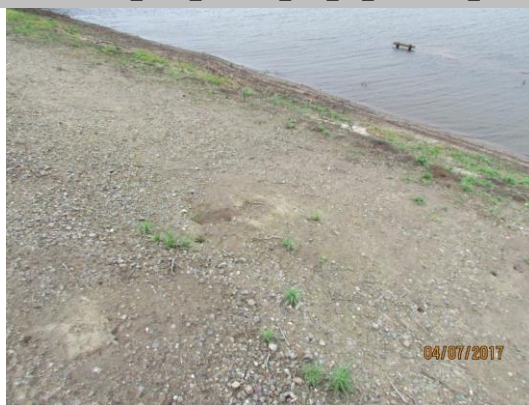
Photo 1 of 1 : SP\_2017\_RD2092\_116\_38\_20170417\_00043.jpg

LM Start	1.58	Rating **	M	Issue No.	38
LM End	1.58	Issue Type +	Ma	Location *	WS
Category	Earthen Levee			GPS Latitude/Longitude	
				Start	End
Item	Animal Control			37.587282 °	37.587282 °
				-121.162641 °	-121.162641 °
DWR ID	DWR_RD2092_01_s_2017_38				
Comment Code					
A3 : No rodents visible, but rodent burrows visible; need to backfill and compact or grout burrows.					
Inspector Comment

View of a rodent hole on the waterside of the levee.

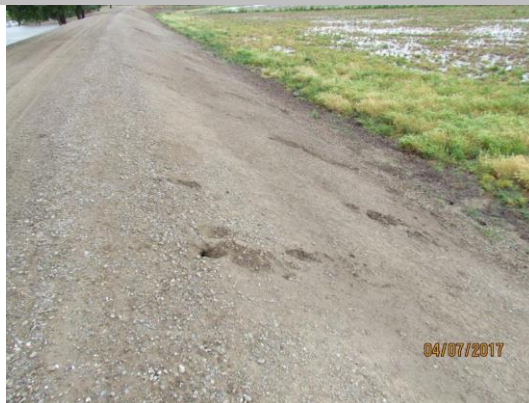
Photo 1 of 1 : SP\_2017\_RD2092\_116\_21\_20170417\_00037.jpg

LM Start	1.66	Rating **	M	Issue No.	21
LM End	1.66	Issue Type +	Ma	Location *	LS
Category	Earthen Levee			GPS Latitude/Longitude	
				Start	End
Item	Animal Control			37.586267 °	37.586267 °
				-121.163209 °	-121.163209 °
DWR ID	DWR_RD2092_01_s_2017_21				
Comment Code					
A3 : No rodents visible, but rodent burrows visible; need to backfill and compact or grout burrows.					
Inspector Comment

View of rodent holes on the landside of the levee looking downstream.

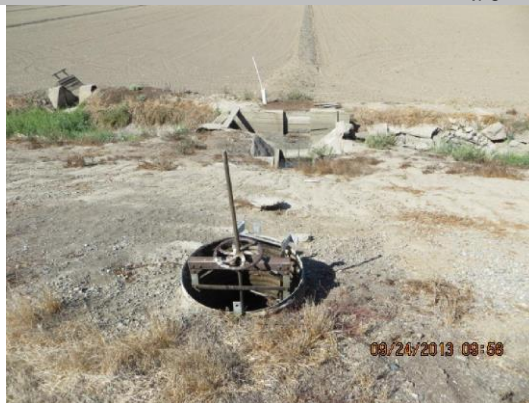
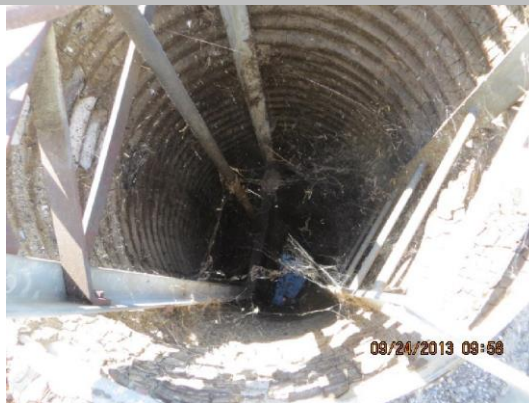
LM Start	1.69	Rating **	A/W	Issue No.	977
LM End	1.69	Issue Type +	Ma	Location *	LS
Category	Supplemental			GPS Latitude/Longitude	
				Start	End
Item	DWR UCIP LMA Responsibility			37.585938 °	37.585938 °
				-121.163348 °	-121.163348 °
DWR ID					
Comment Code					
Inspector Comment					
FS_ID:20891					
DS_ID:20563					
EP_NO: N/A					
Repair Type: No Action Needed					
Crossing Status: Found					
UCIP Comments:					
FIELD_STRUCT_DESC: 24-inch corrugated metal pipe through levee					
14.0 feet below crown. Slide gate in corrugated metal pipe riser on the					
waterward slope. Concrete "U" headwall at the landward toe.					
Originally included in the 1961 O&M manual.					
FS Date: 9/24/2013

Slide gate in 36-inch CMP riser on WS slope.

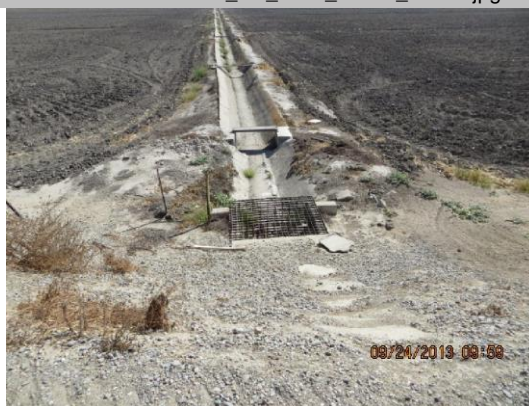
Photo 3 of 3 : UCIP\_SP\_2017\_20891\_35214.jpg

Concrete headwall at base of LS toe.

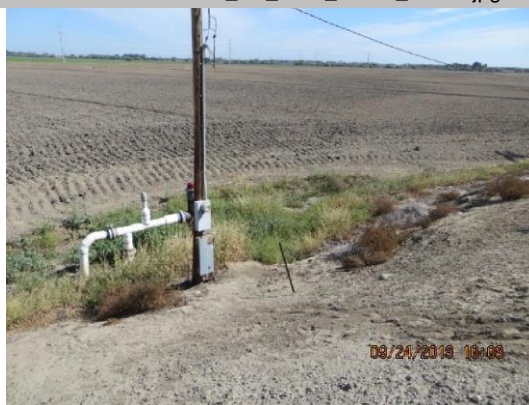
Photo 1 of 2 : UCIP\_SP\_2017\_20904\_35221.jpg

LM Start	2.07	Rating **	A/W	Issue No.	978
LM End	2.07	Issue Type +	Ma	Location *	CR
Category	Supplemental			GPS Latitude/Longitude	
				Start	End
Item	DWR UCIP LMA Responsibility			37.584212 °	37.584212 °
				-121.158347 °	-121.158347 °
DWR ID					
Comment Code					
Inspector Comment					
FS_ID:20904 DS_ID:20564 EP_NO: N/A Repair Type: No Action Needed Crossing Status: Found UCIP Comments: FIELD_STRUCT_DESC: *ABANDONED* 30-inch corrugated metal pipe through levee 15.0 feet below crown. Flap gate on the waterward end. Concrete "U" headwalls on both ends. Filled with concrete on LS toe. Originally included in the 1961 O&M manual. FS Date: 9/24/2013

Pipe and concrete headwall visible on LS toe to right of powerpole.

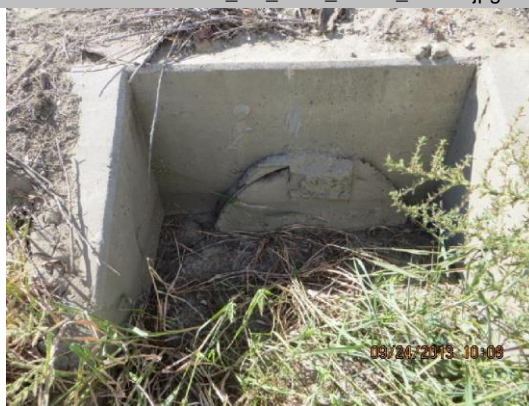
Photo 2 of 2 : UCIP\_SP\_2017\_20904\_35220.jpg

Pipe and concrete headwall visible on LS toe.

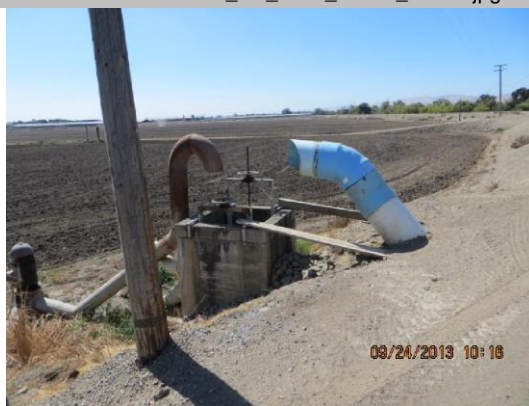
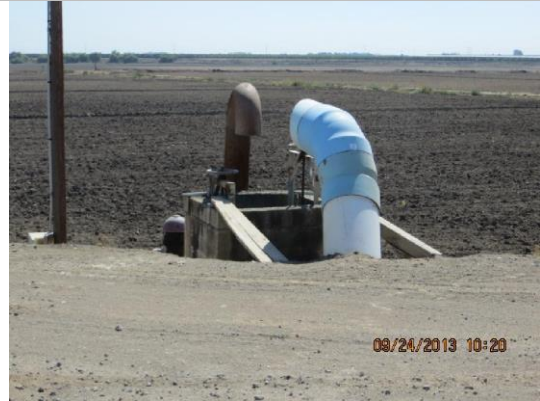
LM Start	2.34	Rating **	M	Issue No.	979
LM End	2.34	Issue Type +	En	Location *	CR
Category	Supplemental			GPS Latitude/Longitude	
				Start	End
Item	DWR UCIP Field Study			37.581226 °	37.581226 °
				-121.156175 °	-121.156175 °
DWR ID					
Comment Code					
Inspector Comment					
FS_ID:22916 DS_ID:24680 EP_NO: N/A Repair Type: Non-Urgent Crossing Status: Found UCIP Comments: No permit identified for this crossing. FIELD_STRUCT_DESC: 21-inch PVC irrigation pipe through the levee at an unknown depth below the crown. Pipe discharges into concrete distribution box on LS toe. Pump on pier off WS toe. FS Date: 9/24/2013

21-inch PVC irrigation pipe visible on LS shoulder.

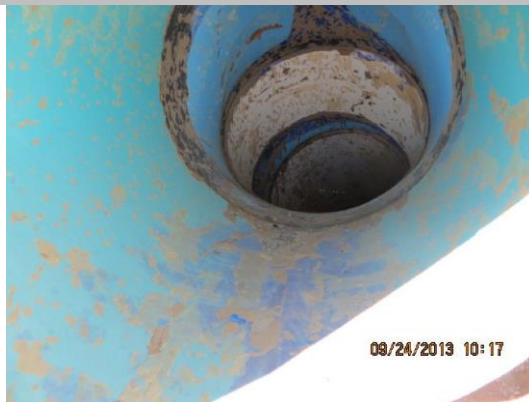
Photo 2 of 3 : UCIP\_SP\_2017\_22916\_39045.jpg

Inside of pipe at LS shoulder.

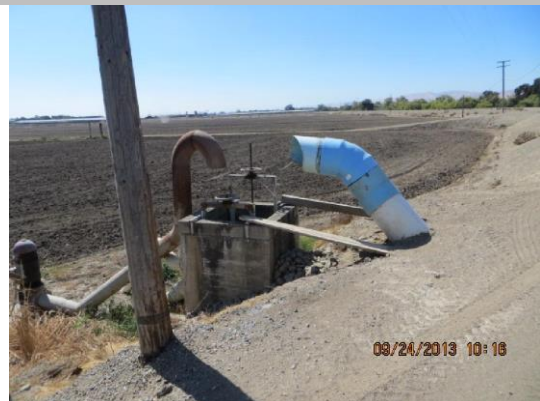
Photo 1 of 3 : UCIP\_SP\_2017\_20908\_35229.jpg

LM Start	2.34	Rating **	M	Issue No.	980
LM End	2.34	Issue Type +	En	Location *	CR
Category	Supplemental			GPS Latitude/Longitude	
				Start	End
Item	DWR UCIP Field Study			37.581213 °	37.581213 °
				-121.156175 °	-121.156175 °
DWR ID					
Comment Code					
Inspector Comment					
FS_ID:20908 DS_ID:20566 EP_NO: N/A Repair Type: Non-Urgent Crossing Status: Found UCIP Comments: Pipe appears abandoned and needs to be verified as having been done so properly. FIELD_STRUCT_DESC: *ABANDONED* 24-inch corrugated metal pipe through levee 11.0 feet below crown. Slide gate in 36-inch corrugated metal pipe riser on the waterward slope. 5'X5' Concrete distribution box on the landward side. Pump on platform in channel. Pipe filled with concrete on LS toe. Originally included in the 1961 O&M manual. FS Date: 9/24/2013

5x5 concrete distribuion box on LS toe.

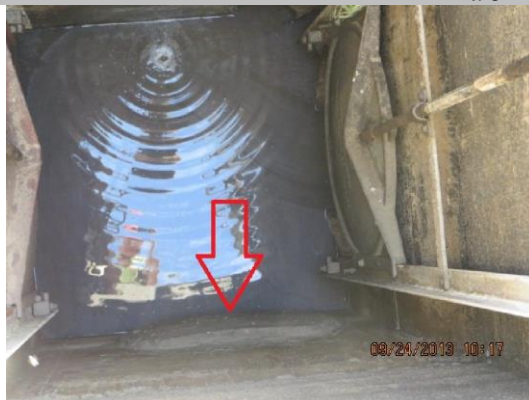
Photo 2 of 3 : UCIP\_SP\_2017\_20908\_35227.jpg

Pipe filled with concrete inside conc. distro box on LS toe.

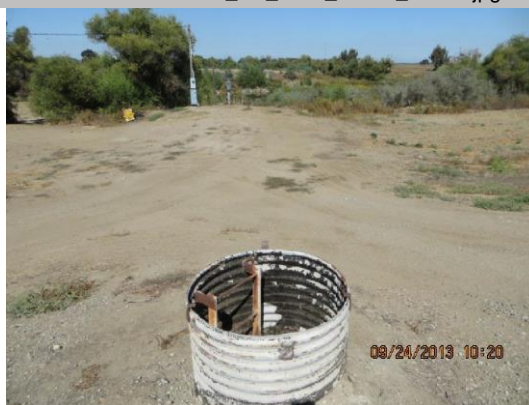
Photo 3 of 3 : UCIP\_SP\_2017\_20908\_35223.jpg

36-inch CMP riser on WS slope.

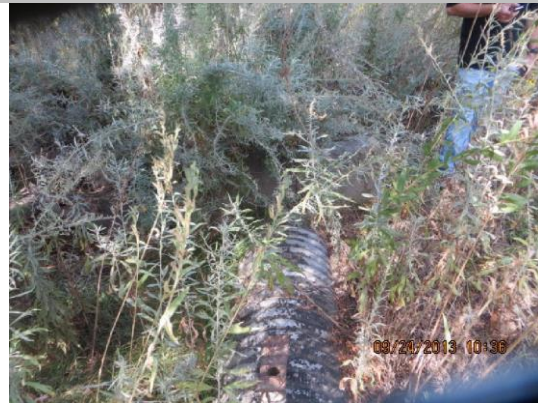
Photo 1 of 3 : UCIP\_SP\_2017\_20943\_35251.jpg

LM Start	2.40	Rating **	M	Issue No.	981
LM End	2.40	Issue Type +	Ma	Location *	LS
Category	Supplemental			GPS Latitude/Longitude	
				Start	End
Item	DWR UCIP LMA Responsibility			37.580426 °	37.580426 °
				-121.156798 °	-121.156798 °
DWR ID					
Comment Code					
Inspector Comment					
FS_ID:20943 DS_ID:20567 EP_NO: N/A Repair Type: Non-Urgent Crossing Status: Found UCIP Comments: Appears abandoned and if so should be done so properly. FIELD_STRUCT_DESC: *ABANDONED* 24-inch corrugated metal drain pipe through levee 15.0 feet below crown. Flap gate on the waterward end. Concrete "U" headwall on the waterward end and concrete headwall on LS toe next to pump. Originally included in the 1961 O&M manual. FS Date: 9/24/2013

24-inch pipe visible on WS berm.

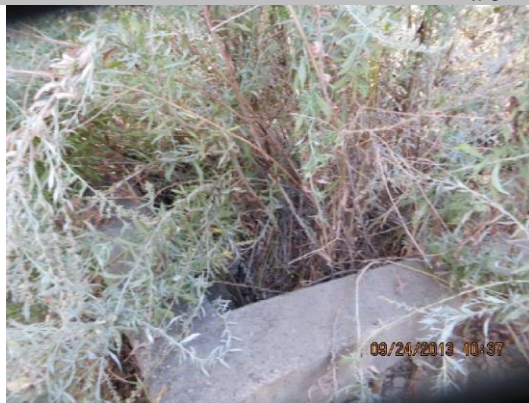
Photo 2 of 3 : UCIP\_SP\_2017\_20943\_35250.jpg

Concrete U-shaped headwall and flapgate on WS berm.

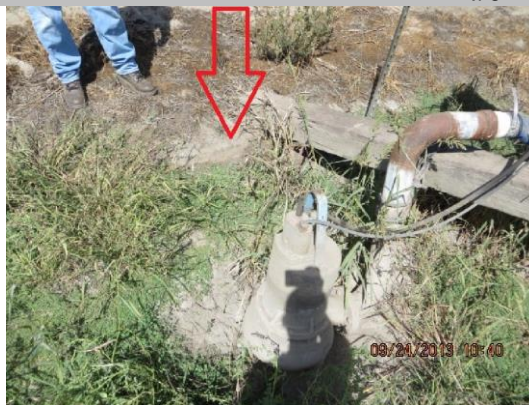
Photo 3 of 3 : UCIP\_SP\_2017\_20943\_35252.jpg

Concrete headwall next to pump on WS toe.

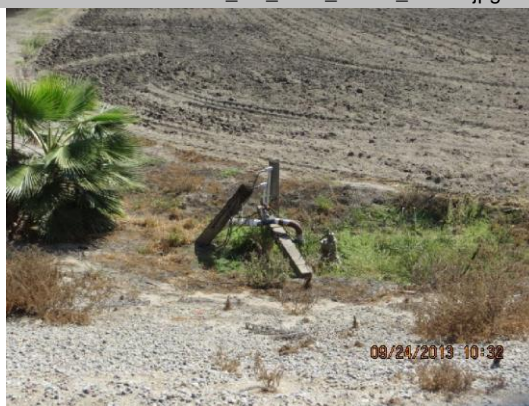
Photo 1 of 3 : UCIP\_SP\_2017\_20923\_35234.jpg

LM Start	2.41	Rating **	M	Issue No.	982
LM End	2.41	Issue Type +	En	Location *	LS
Category	Supplemental			GPS Latitude/Longitude	
				Start	End
Item	DWR UCIP Field Study			37.580405 °	37.580405 °
				-121.156825 °	-121.156825 °
DWR ID					
Comment Code					
Inspector Comment					
FS_ID:20923					
DS_ID:20568					
EP_NO: N/A					
Repair Type: Non-Urgent					
Crossing Status: Indicator Found					
UCIP Comments: Pipe abandoned and should be verified as having been removed from the levee.					
FIELD_STRUCT_DESC: *ABANDONED* 4-inch pipe through levee 1.0 foot below crown. Pump on sump at LS toe. Roadway extending to the landward pump.					
FS Date: 9/24/2013

Pump and 4-inch pipe visible at LS toe.

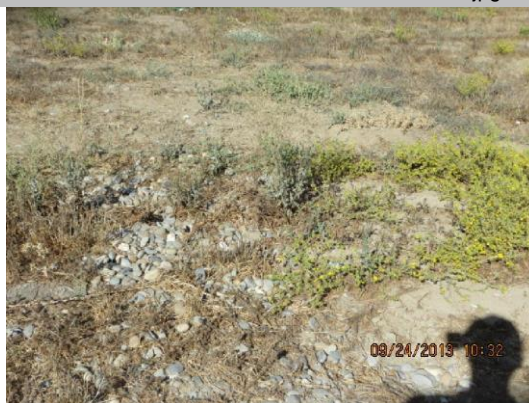
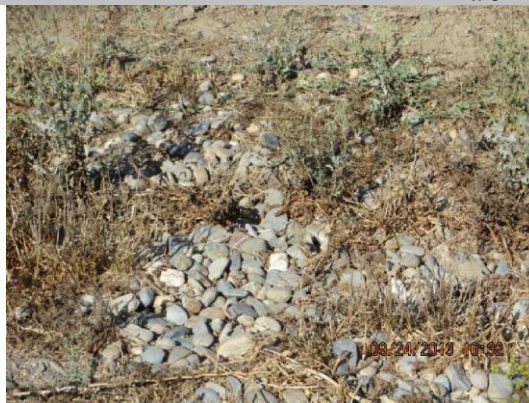
Gravel on WS slope appears to indicate trench.

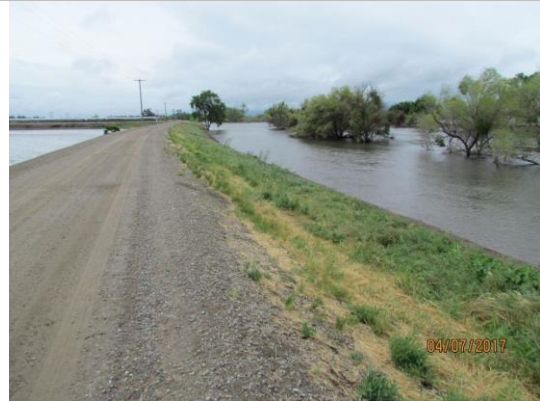
Photo 1 of 1 : SP\_2017\_RD2092\_116\_32\_20170417\_00039.jpg

View of vegetation on the waterside slope of the levee. Spring 2017

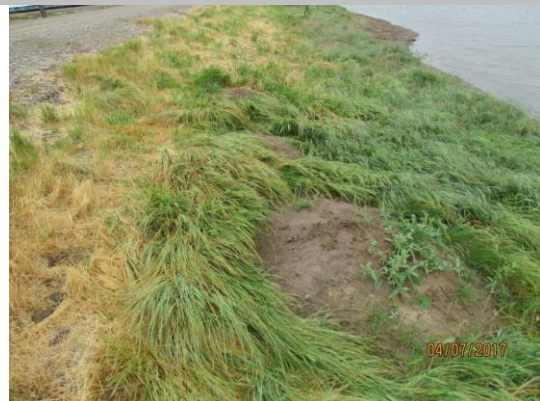
Photo 1 of 1 : SP\_2017\_RD2092\_116\_36\_20170417\_00042.jpg

View of a rodent hole on the waterside slope of the levee.

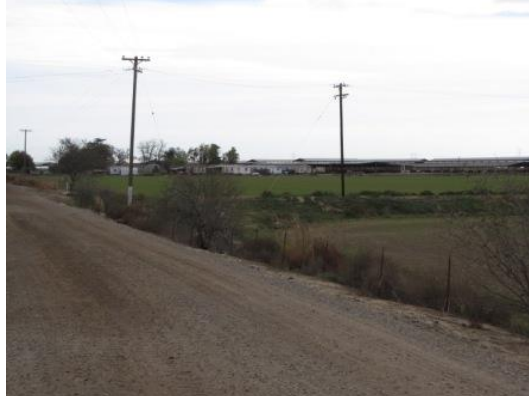
Photo 1 of 1 : SP\_2017\_RD2092\_116\_972\_20170327\_00007.jpg

View of barbed wire fence along the waterward slope looking upstream.

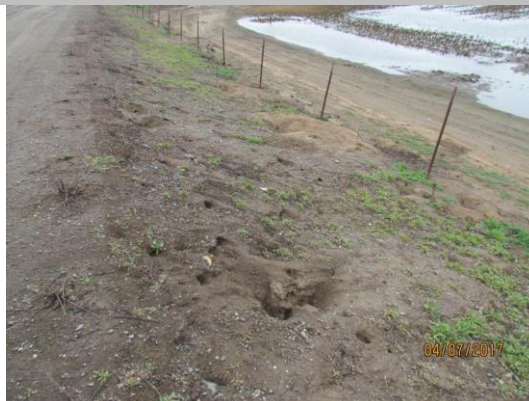
Photo 1 of 1 : SP\_2017\_RD2092\_116\_35\_20170417\_00041.jpg

View of multiple rodent holes on the waterside slope of the levee. Spring 2017

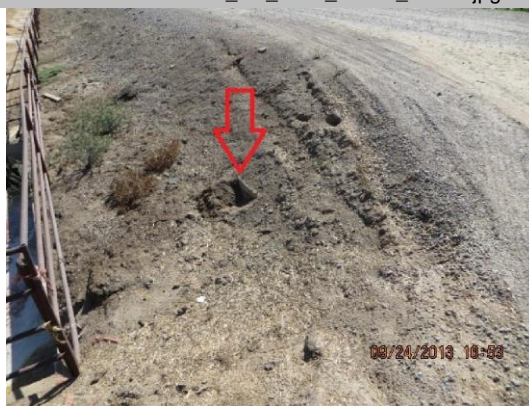
Photo 1 of 1 : UCIP\_SP\_2017\_20944\_35255.jpg

Concrete headwall visible on LS slope.

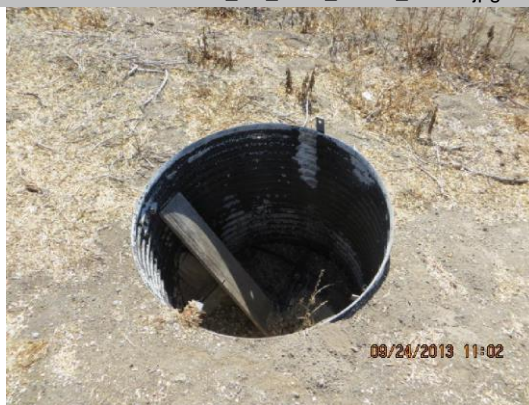
Photo 1 of 3 : UCIP\_SP\_2017\_20945\_35261.jpg

48-inch CMP riser on WS slope.

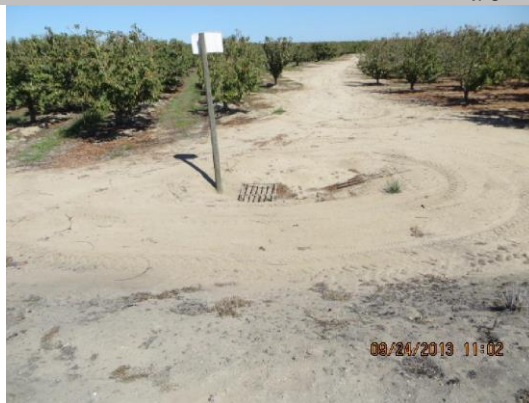
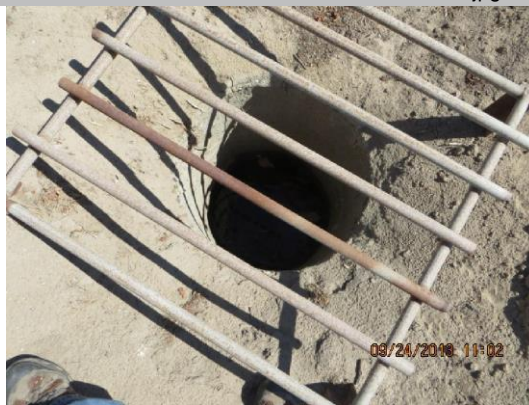
Grate over sump on LS toe.
